Manhole Inspection Summary

Manhole # S39I__043MH

Insp Date: **8/19/08 12:46 PM**

Location Address: **701 e pratt st**

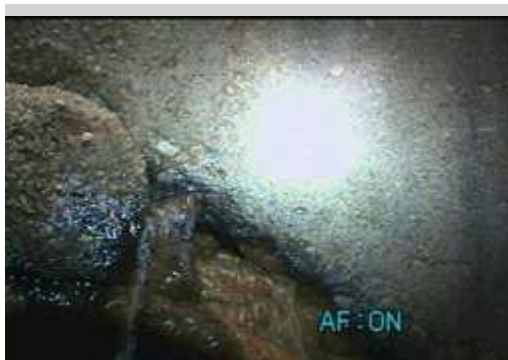
Defect 2

channel debris

bench debris

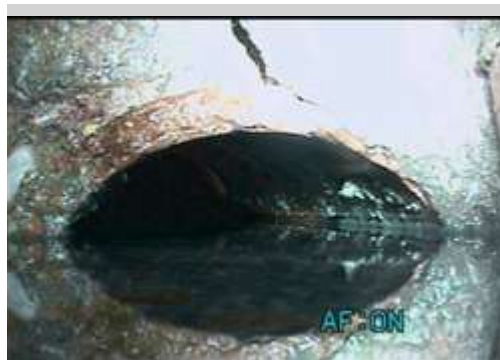
defect 3

Condition: ☐ Sound ☒ **Cracked** ☐ Root Intrusion ☐ Loose Brick ☐ Deteriorated

Infiltration: ☐ None ☐ Joint ☒ **Cracks** ☐ Mortar ☐ Roots ☒ **Wall**

infiltration

barrel cracked

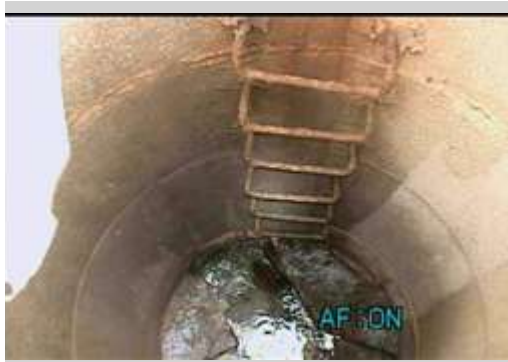
Defect 1

Count: **9** Missing: **0** ☒ **Corroded**

corroded steps

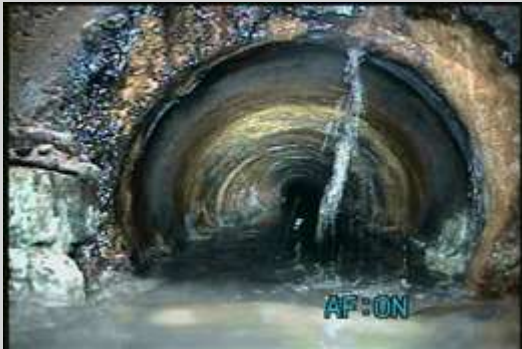
12 O'Clock Outflow

15 in. Circular Gravity Sewer
Pipe Out @ 12 O'Clock

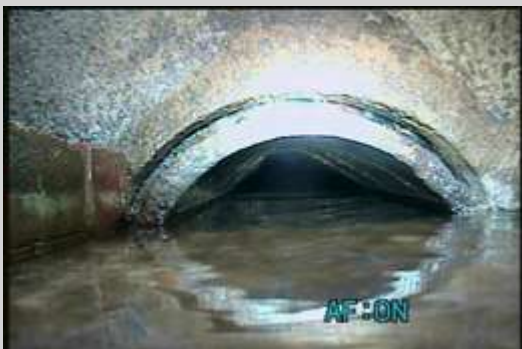
5 O'Clock Inflow

12 in. Circular Gravity Sewer
Pipe In @ 5 O'Clock

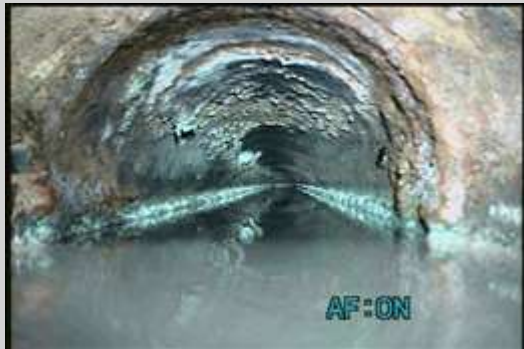
6 O'Clock Inflow

15 in. Circular Gravity Sewer

Pipe In @ 6 O'Clock

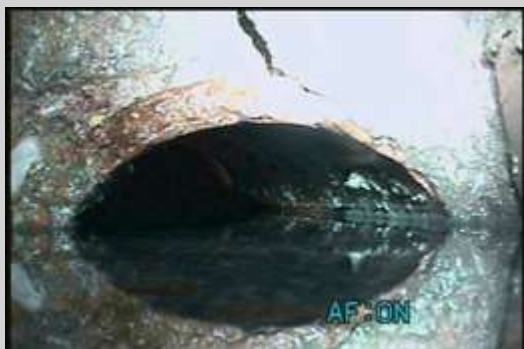
9 O'Clock Inflow

10 in. Circular Gravity Sewer

Pipe In @ 9 O'Clock

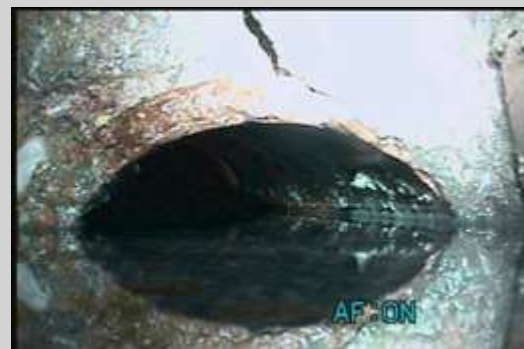
defect 3

barrel cracked
